# MOD Infrastructure Case Study

The following project was quoted and executed on account of LCM Environmental.

## The Task

**Two DIO base boiler houses, fed by underground diesel fuel tanks were to be excavated, decommissioned, and replaced.**

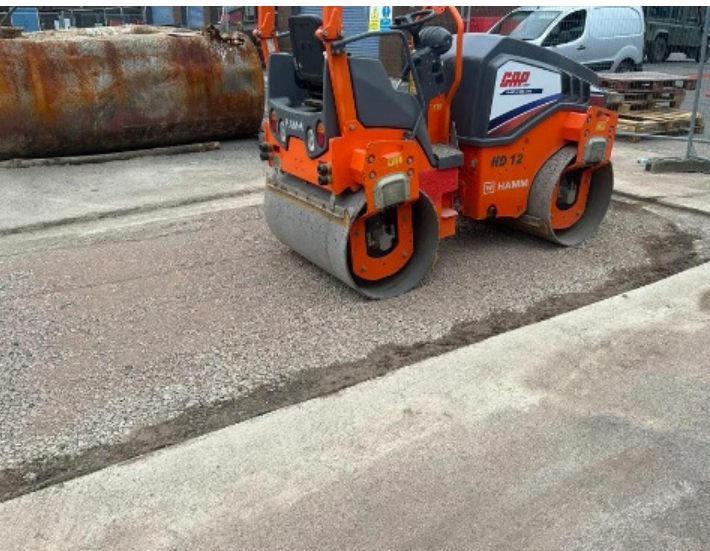
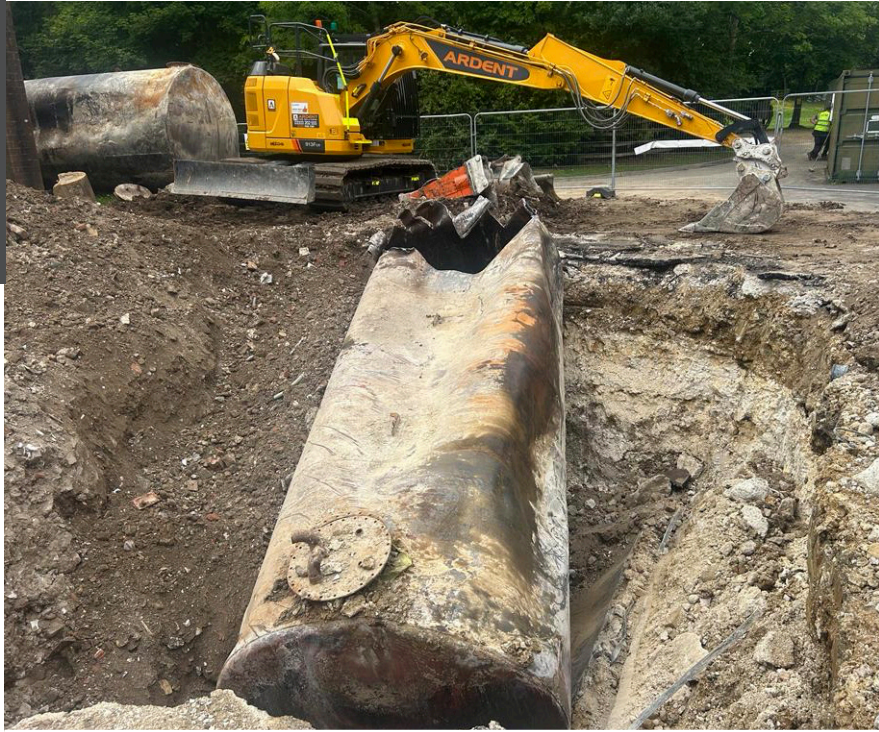
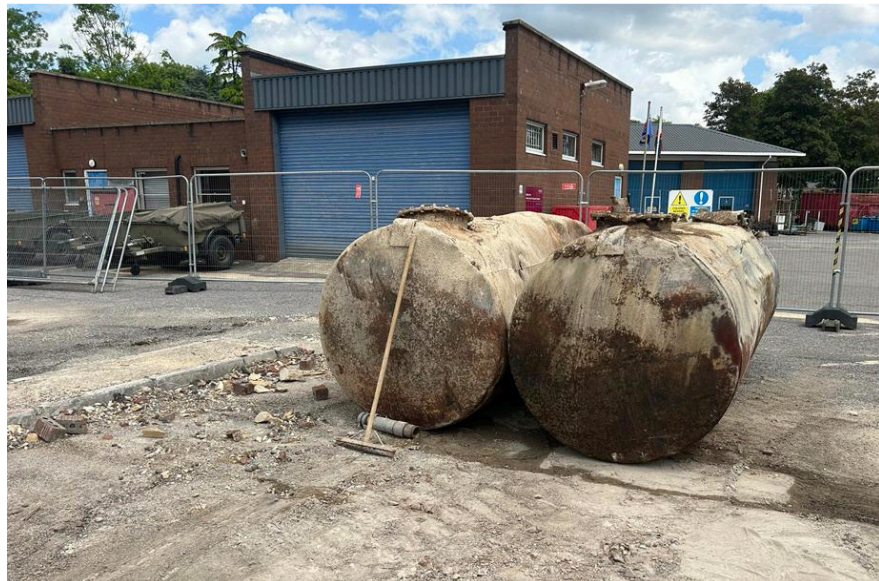
The team ensured that Vinci's temp works process is fully adhered to, and all excavation works were supported. Once the fuel vessels were removed from the ground, we filled the space with compacted 6F5 granular material and topped it with 150mm of type 1 MOT.

The civil works were completed with a top of reinforced structural concrete base, taking into consideration the placement of new fuel tanks, and leaving a minimum of 1m distance. Any disturbed tarmac was made to match existing line markings were redone once the new 54,000L above-ground fuel tank was supplied and installed.

The new fuel tank was placed on top of the concrete base, supported by brick/block piers, so that the bottom of the tank can be regularly inspected. A lockable fill cabinet contained the fill point of the tank, as well as the filler connection, tank contents gauge, the bund and overfill alarms.

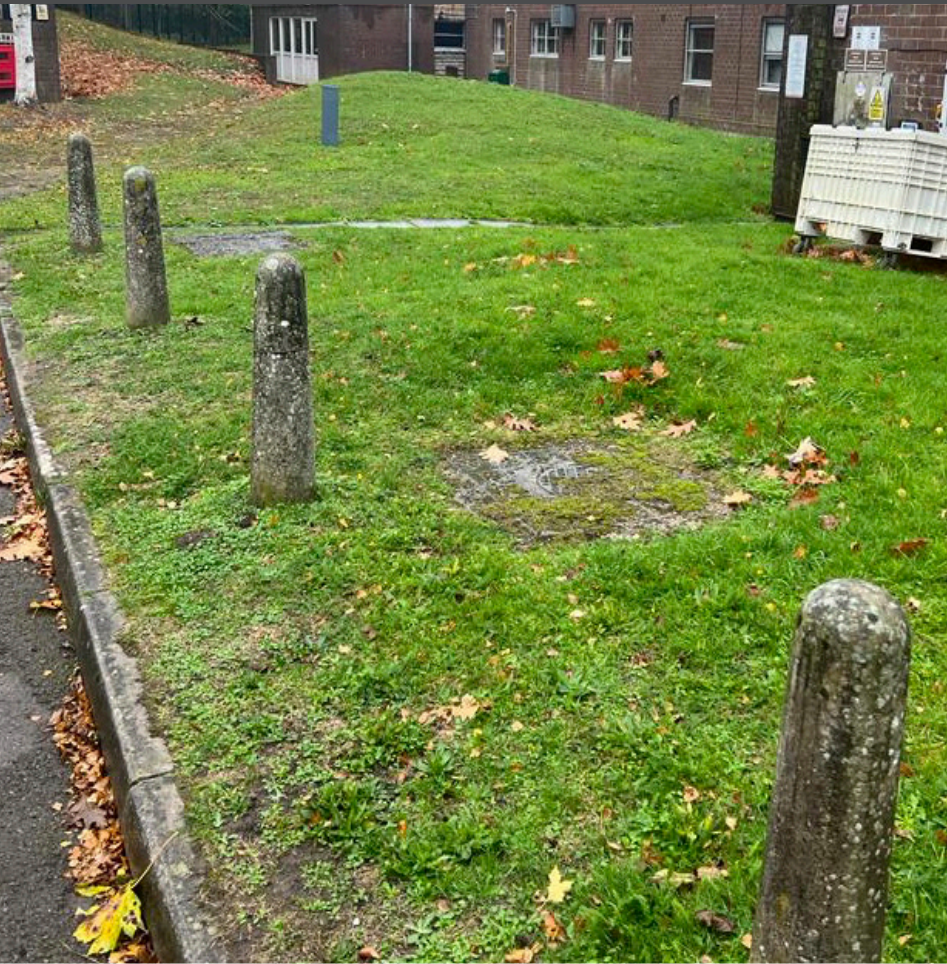
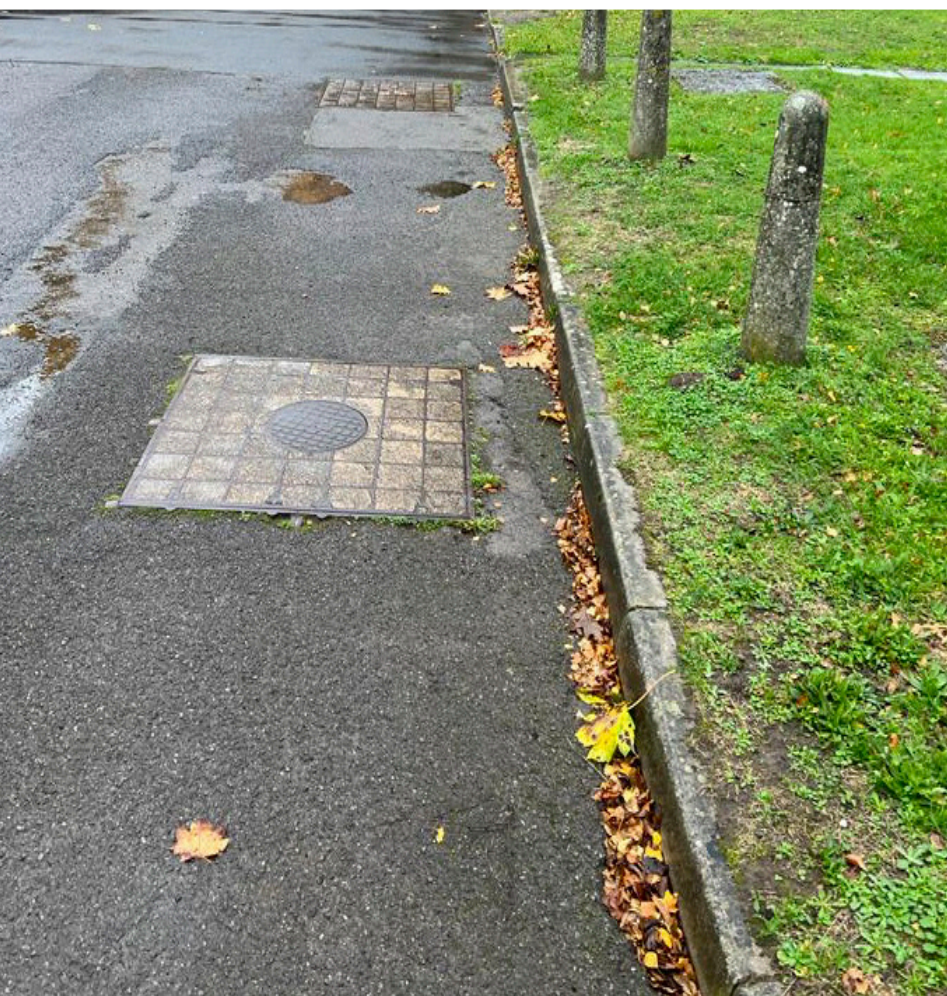
# North Boiler House 25

The same works as described above took place, apart from tank storage size.

The tanks in the North Boiler house were 25,000L each. An additional 1,000L day tank was cleared out and cleaned out to a gas-free standard before being disposed of, ensuring all associated pipework, pumps and controls across the entire site were removed and disposed of accordingly.

A new drainage ring, completed with an interceptor and interceptor alarm were installed to keep the site safe when fuel deliveries take place and protect against any catastrophic spillages.

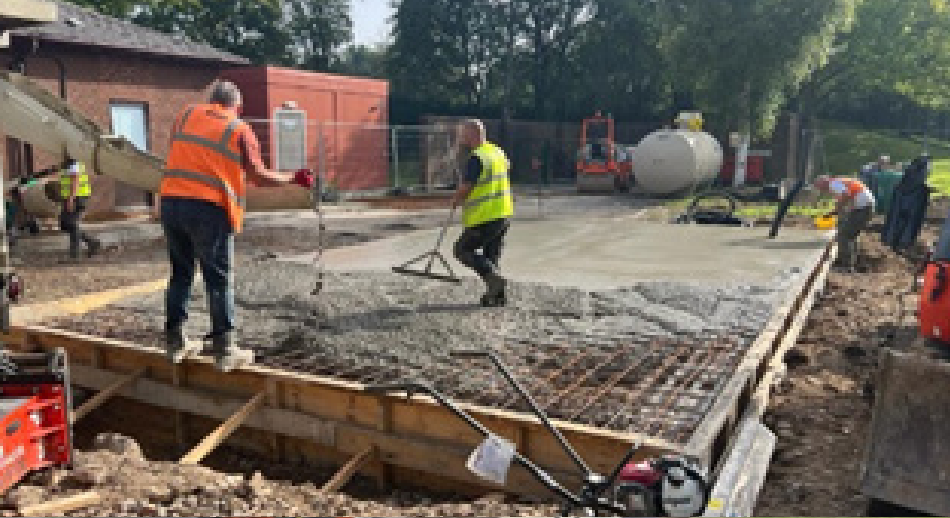
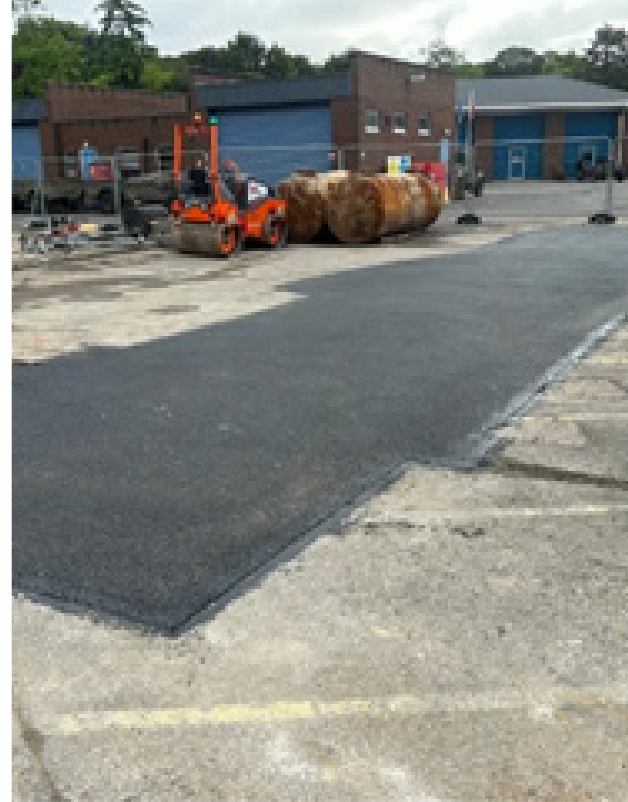
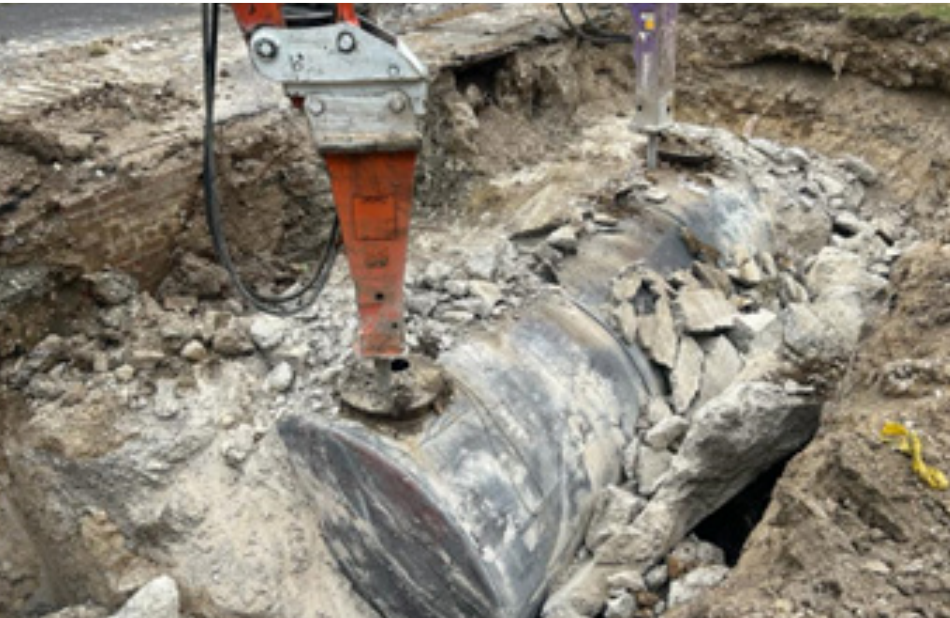
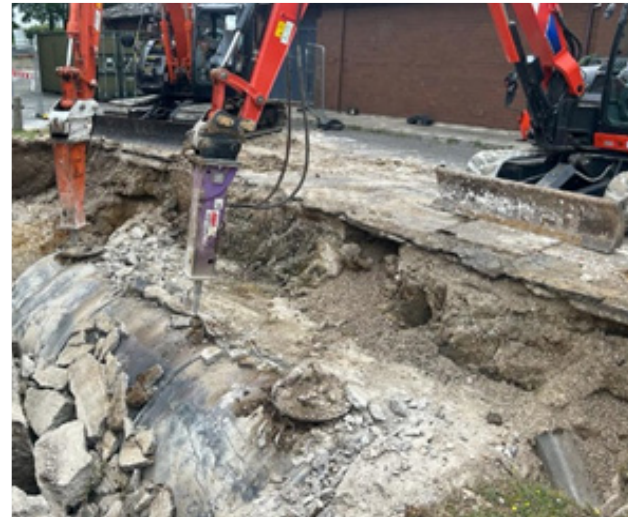
# MT

**The two in-situ 10,000L tanks had been decommissioned (foam filled) more than 20 years ago; the ECS team had to excavate them and dispose of them.**

The engineers then filled the excavated area with compacted 6F5 granular material and topped it with 150mm of type 1 MOT. The top base coat was tarmac to match the existing roadway, where all disturbed road markings were reapplied.

The ECS team demolished a wooden frame office building and a bricked store building, removing the pump island and reinstating the ground back to an even roadway.
